FINAL REPORT JULY 2007

REPORT NO. 06-04D

EVALUATION TRANSPORTABILITY TESTING OF THE JOINT MODULAR INTERMODAL PLATFORM (JMIP) UNIT #4

EVALUATION TRANSPORTABILITY TESTING OF THE JOINT MODULAR INTERMODAL PLATFORM (JMIP) UNIT #4 TP-94-01, REV. 2, JUNE 2004, "TRANSPORTABILITY TESTING PROCEDURES"

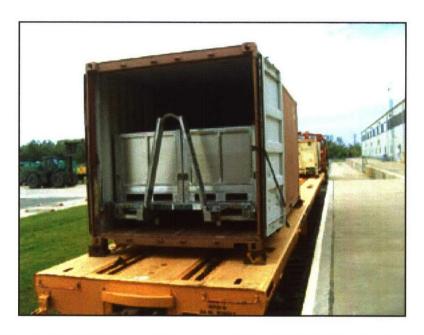
Photo 2. Rail Impact Testing of the JMIP (Prior to Testing)

Remarks: Figure 4 lists the test components and weights of the items used during the Rail Impact Tests.

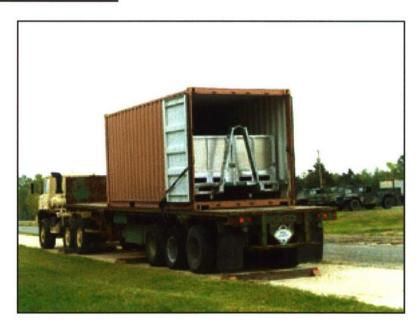
Photo 3. Hazard Course Testing of the JMIP

- 1. Figure 6 lists the average speeds of the test load through the Hazard Course.
- 2. Inspection did not reveal any damage to the JMIP.

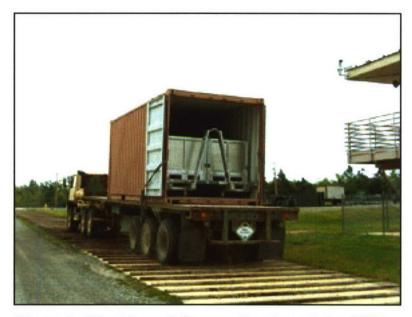
Photo 4. Washboard Course Testing of the JMIP

Inspection following the Washboard Course revealed no damage to the JMIP.

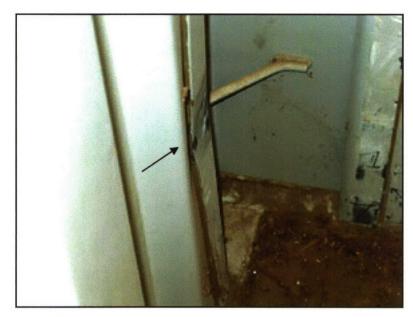
4. The container corner posts at the closed end were damaged due to contact with the hard blocks on the JMIP.

Photo 7. Damaged Container Corner Post

- 1. The JMIP, as currently designed, is <u>not adequate</u> to transport the Navy JMICs, in an intermodal container due to the damage the JMIP end blocks caused to the intermodal container.
- 2. The purpose of the testing was to identify the adequacy of the JMIP for demonstration use and not final approval. Testing has identified deficiencies with the current design.
- 3. The operational condition of the JMIP should be closely monitored during the demonstration. Also, the Defense Ammunition Center, Transportation Engineering Division, shall be consulted for the ammunition loading and bracing instructions.

Note: The hard plastic end blocks were replaced with a softer rubber end bumpers for follow on testing (06-04F, 06-04G, 06-04H, 06-04J). The intermodal container corner posts were not damaged during testing when the softer rubber end bumpers were used. Therefore, the JMIP with the soft rubber end bumpers, is adequate to be used in container transport.

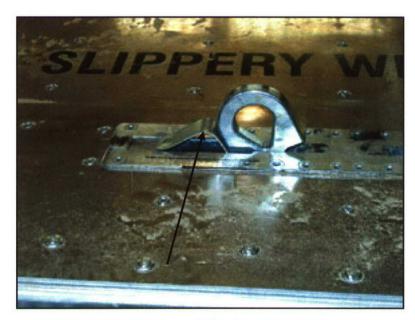
1. Final inspection following the removal of the JMICs revealed that the spring steel JMIC lock covers were damaged.

Photo 8. Damaged Spring Steel Covers

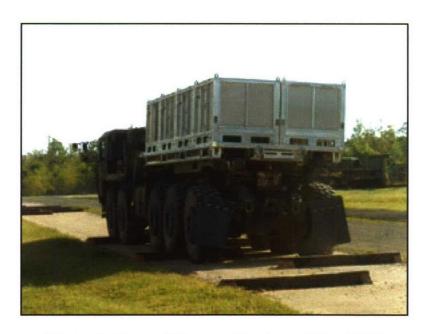
Photo 9. Hazard Course Testing of the JMIP

- 1. Figure 9 lists the average speeds of the test load through the Hazard Course.
- 2. Inspection did not reveal any damage to the JMIP.

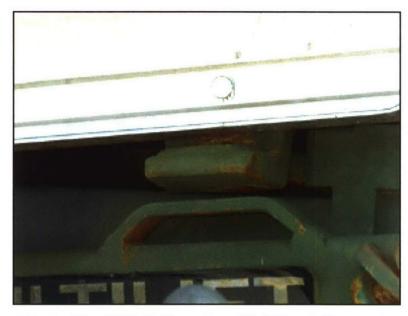
B. <u>OBSERVATION:</u> The rails at the front of JMIP #4 did not rest on the PLS truck supports (frog feet) and the holes in the JMIP rail did not align with the rail transport pin hole on the PLS truck.

Photo 10. JMIP Rails not on PLS Truck Supports

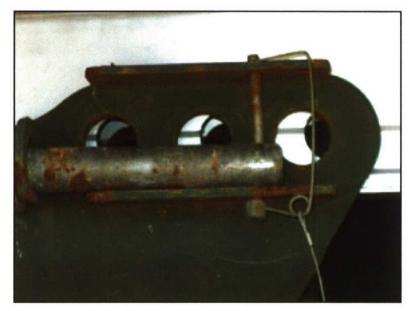
Photo 11. Misalignment of Rail Transport Pin Holes

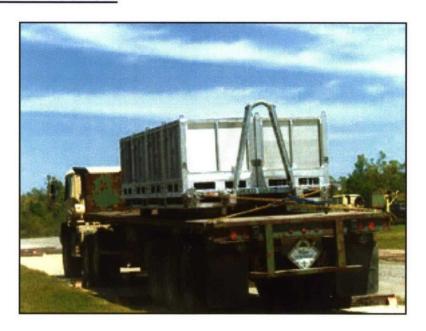
Photo 13. Hazard Course Testing of the JMIP

- 1. Figure 11 lists the average speeds of the test load through the Hazard Course.
- 2. Inspection did not reveal any damage to the JMIP.

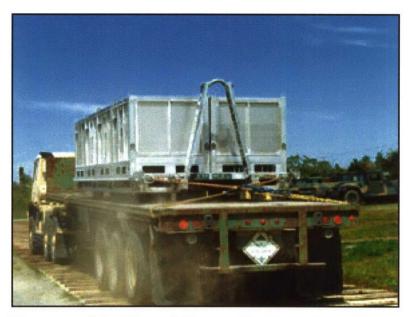
Photo 14. Washboard Course Testing of the JMIP

Remarks: Inspection following the Washboard Course revealed no damage to the JMIP.

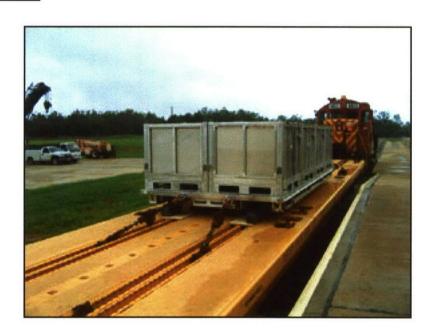
Photo 15. Rail Impact Testing of the JMIP (Prior to Testing)

- 1. Figure 13 lists the average speeds of the specimen car immediately prior to impact with the anvil. Impact #5 is the reverse impact.
- 2. Impact #4 was determined to be a "no test" due to the insufficient velocity at impact. The test was repeated.
- 3. Following Impact # 4 one JMIC door lock was partially disengaged.

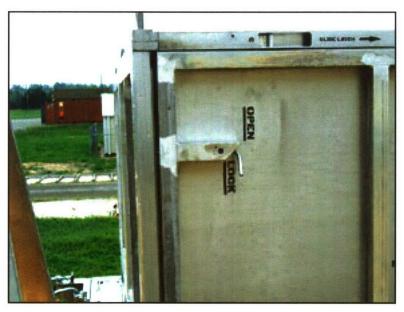
Photo 16. Partially Disengaged JMIC Door Lock
